FUTURELAKES

Demonstrating Successful Restoration

Demonstration Site Descriptions

Deliverable D4.1 Annexes A - F

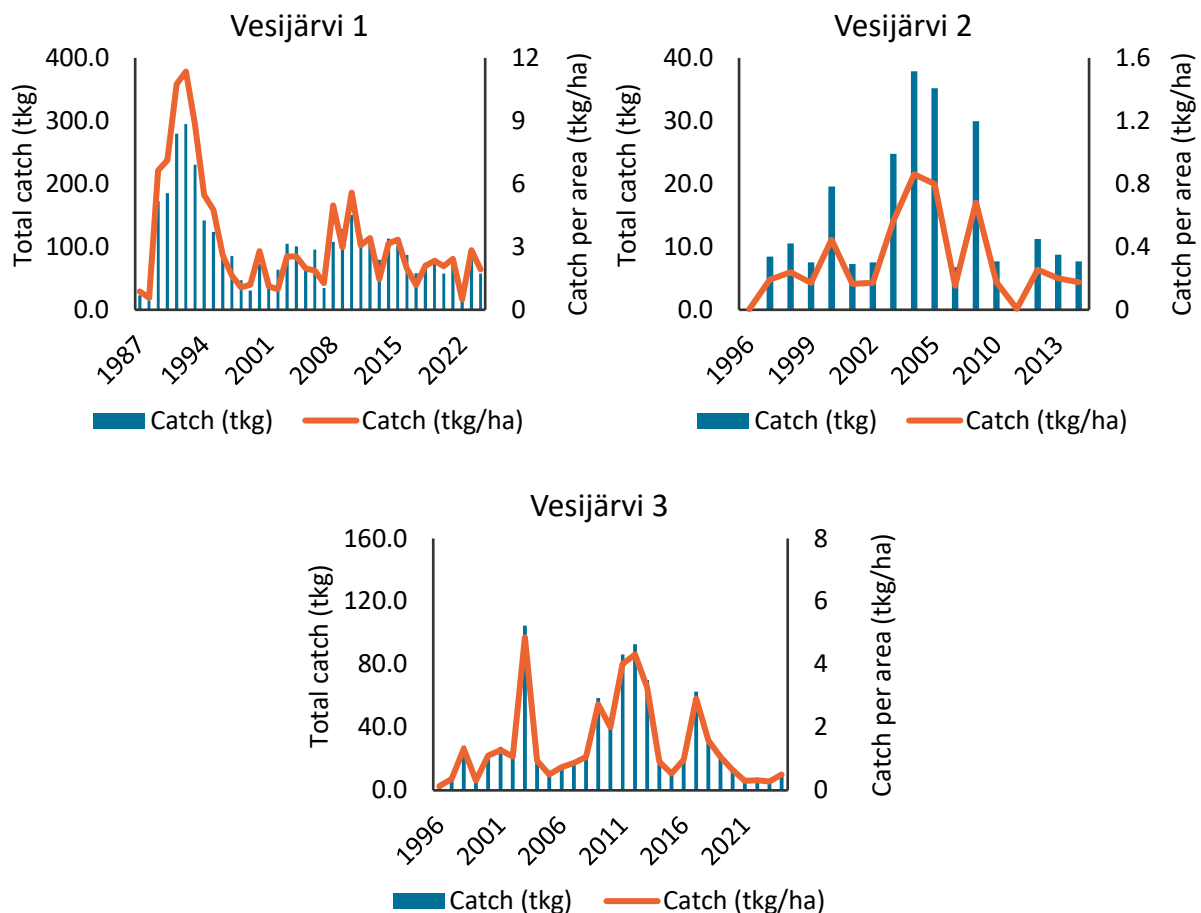
Figure 4. Annual biomanipulation catch of fish at the distinct RBMP water bodies of L. Vesijärvi (Vesijärvi 1 = Enonselkä, Paimelanlahti-Vähäselkä and Komonselkä; Vesijärvi 2 = Kajaanselkä; and Vesijärvi 3 = Laitialanselkä and Kirkonselkä basins). Please refer to Figure 1 for information on the location of these basins. Data from the City of Lahti. Note the different scales on x- and y-axes.

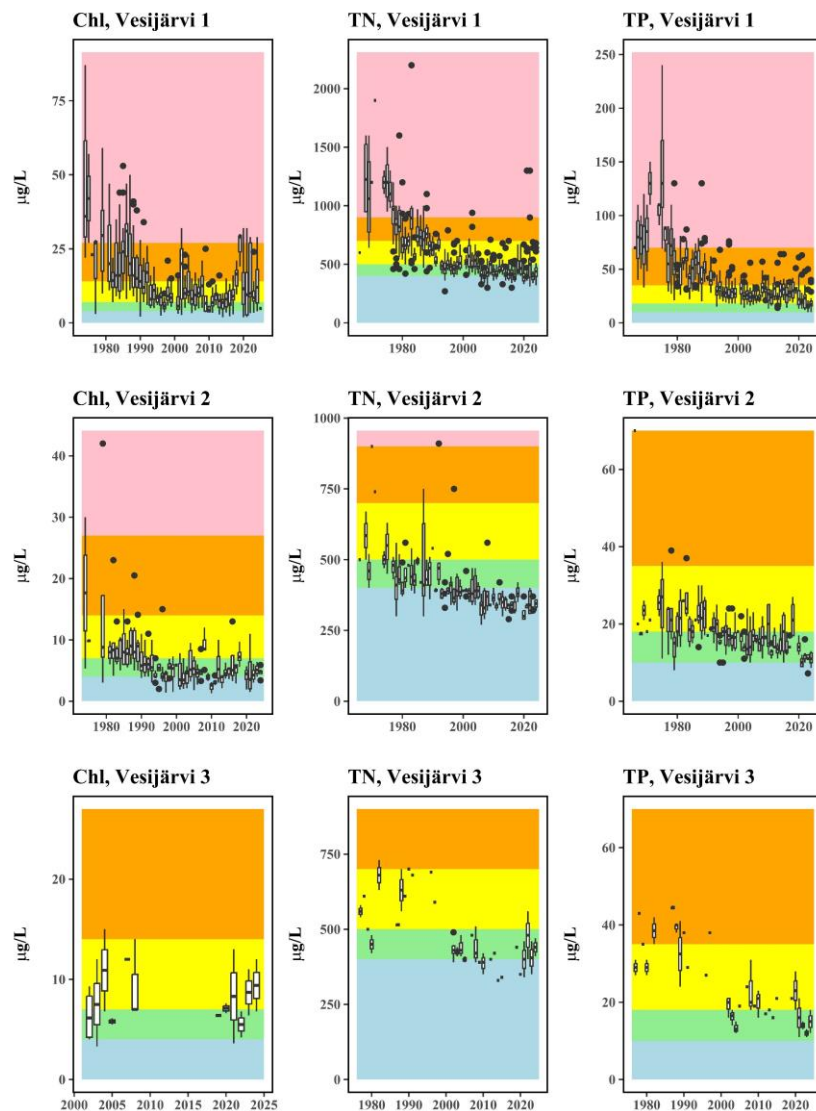
Figure 6. Development of chlorophyll *a* (Chl *a*), total nitrogen (TN) and total phosphorus (TP) concentrations in the three RBMP water bodies of L. Vesijärvi since the beginning of monitoring. Vesijärvi 1 refers to basins Enonselkä, Paimelanlahti-Vähäselkä and Komonselkä; Vesijärvi 2 to Kajaanselkä; and Vesijärvi 3 to Laitialanselkä and Kirkonselkä. The reader is suggested to refer to Figure 1 for information on the location of these basins. Note the different scales on x- and y-axes. The colours represent status class boundaries for phytoplankton metric Chl *a* and the supporting elements TN and TP (blue = high; green = good; yellow = moderate; orange = poor; red = bad).

been observed during the 2010-2020s despite the reduced TP concentrations due to changes in phytoplankton communities (Figure 6, Section 1.3.1.1.2). The aeration of Enonselkä basin in 2010-2019 increased the hypolimnetic oxygen concentration (Horppila et al. 2015) but did not affect the epilimnetic nutrient concentrations (Salmi et al. 2014; Salonen et al. 2023). However, increased temperature and oxygen concentration in the hypolimnion promoted the benthic N removal via increased denitrification and reduced the accumulation of ammonium in the hypolimnion during stratification (Holmroos et al. 2016).

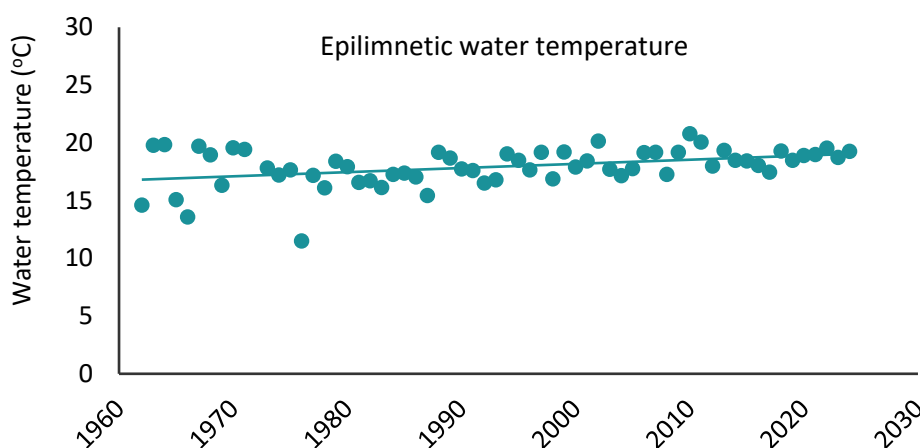
Figure 32. Mean epilimnetic (0-4 m) water temperature during the growing season (June-September) in L. Vesijärvi since the beginning of 1960s.

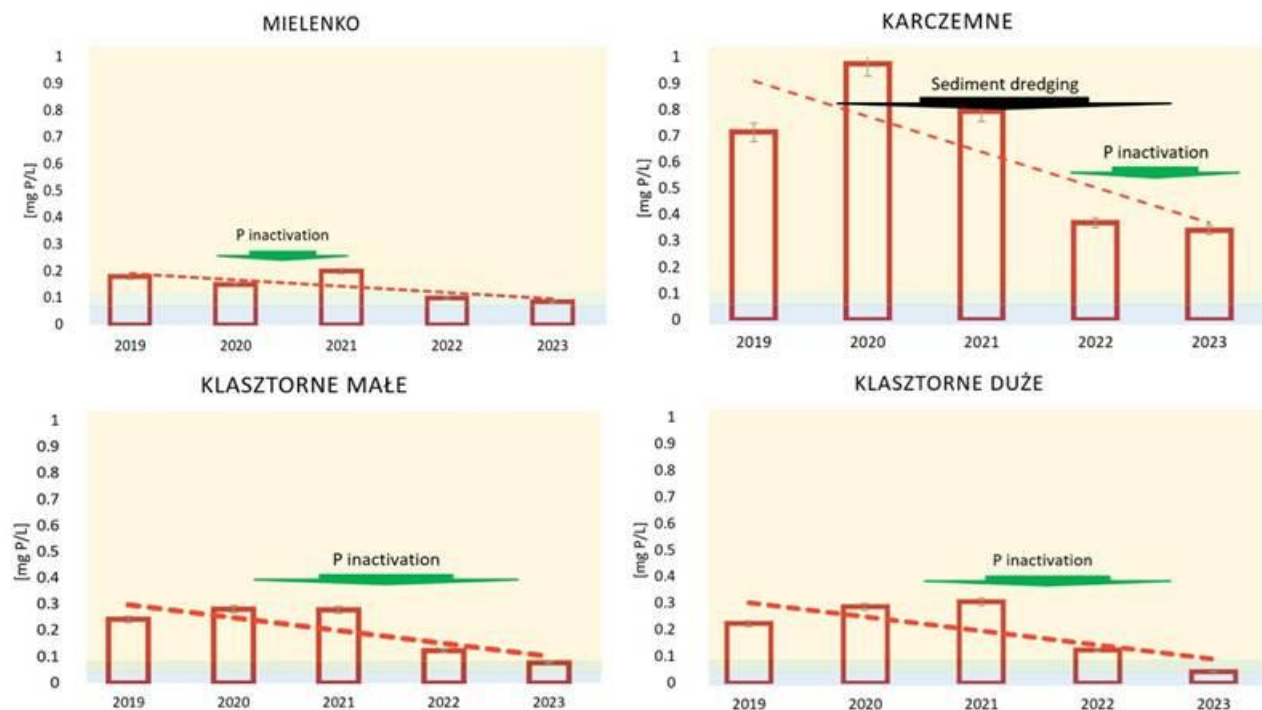
Figure b.3. Changes in average annual concentrations of total phosphorus in Kartuzy Lakes during restoration treatments

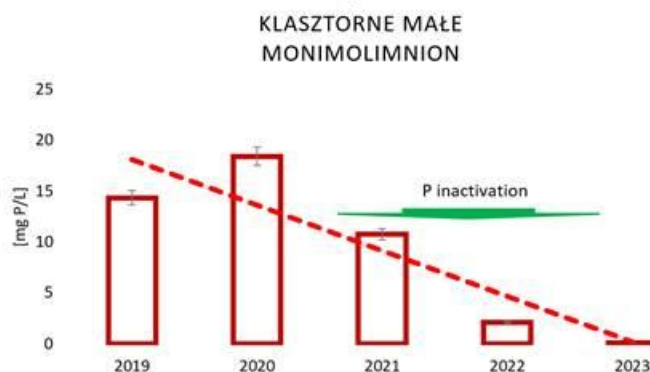
Figure b.4. Changes in average annual concentrations of total phosphorus in monimolimnion of Klasztorne Małe Lake during and after restoration treatments

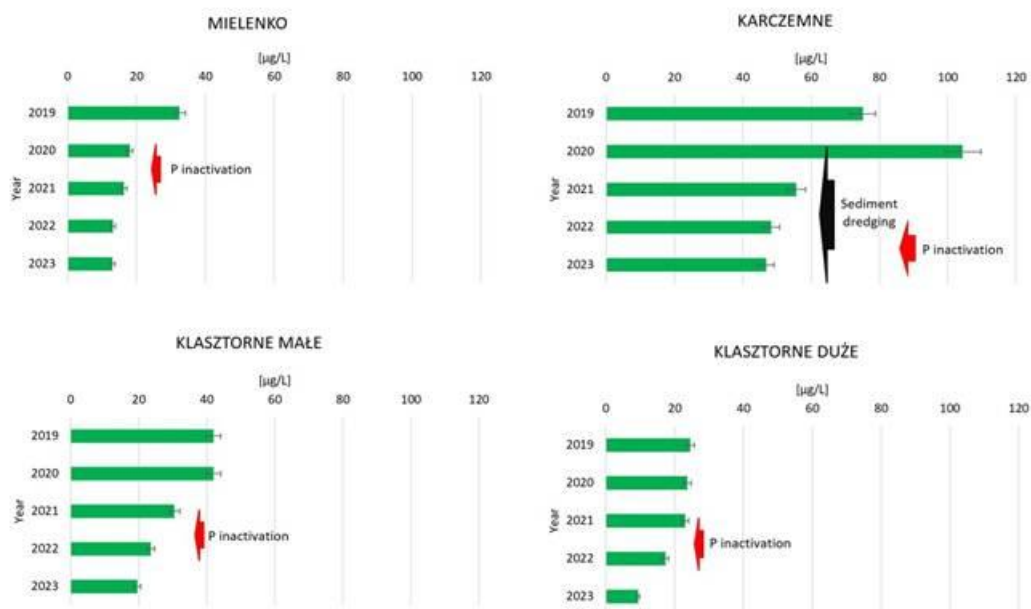
Figure b.7. Changes in average annual concentrations of chlorophyll a in Kartuzy Lakes during restoration treatments

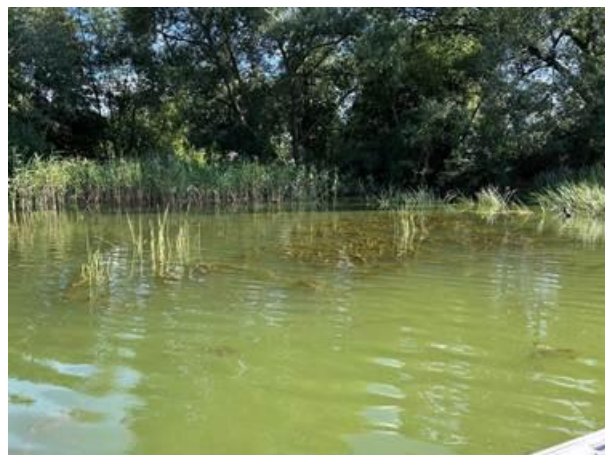
Figure b.12. New place with submerged Potamogeton perfoliatus in the Klasztorne Małe Lake nearby inflow from Karczemne Lake, spotted in summer 2025 (©R. Augustyniak-Tunowska).

https://niva365.sharepoint.com/:f:/r/sites/int_HorizonMISSIONLakerestoration/Shared/Documents/WP4_Demonstration/4.1_Demonstrating-success/Literature-Evaluating-Restoration-Success/Biodiversity-assessment?csf=1&web=1&e=sydQ2w Before restoration, the lakes in Kartuzy were characterized by poor ecological condition, with sparse submerged vegetation communities, or their complete absence (in lakes Karczemne and Klasztorne Małe) and massive phytoplankton blooms. After completing restoration, the new spots of submerged macrophytes are observed (Figs. b.12, b.13, b.14).

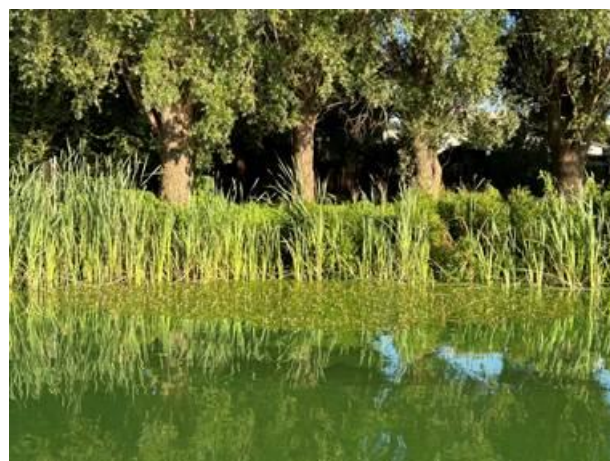
Figure b.13. New place with blooming *Potamogeton natans* nearby east shore of Karczemne Lake, spotted in summer 2025 (© R. Augustyniak-Tunowska).

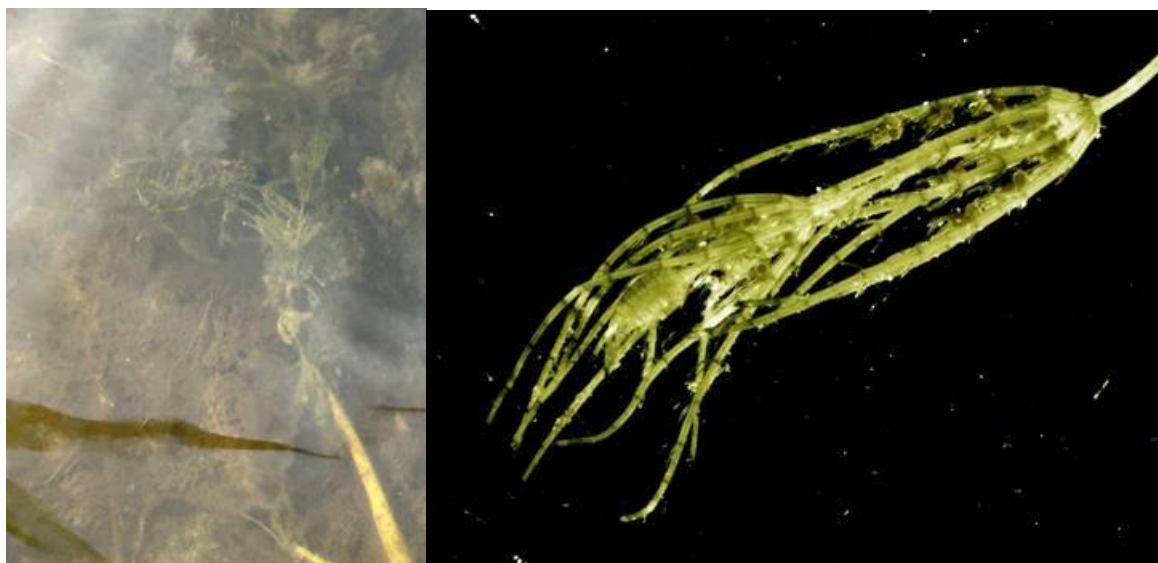
Figure b.14. *Chara delicatula*, spotted in summer 2025 in Mielenko Lake (©R. Augustyniak-Tunowska, A. Hutorowicz)

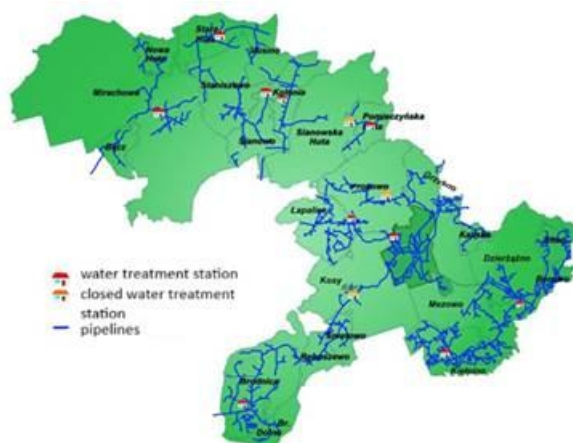
Figure b.18. Water supply system in Kartuzy Commune (source: KPWiK website, <https://www.kpwik.kartuzy.pl/>)

The Kartuzy water supply system is an open-circuit ring system, directed to the city and nine surrounding villages from seven wells (140-150 meters deep). The KPWiK operates a total of 37 deep wells and 13 water treatment plants. Water is supplied to approximately 32,000 residents. The water supply network is 484 km long, and approximately 1,900 hydrants are installed in the network. The scheme of water supply net is presented on Fig. b.18.

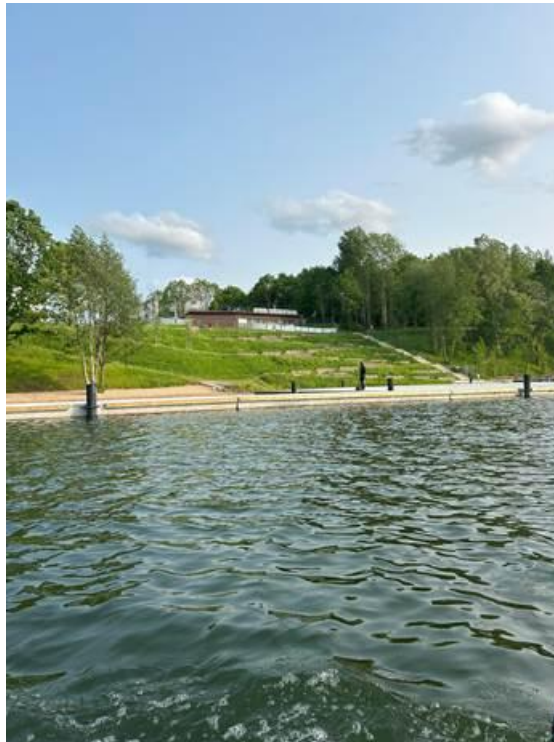
Figure b.22. Beach arrangement construction on the shore of Klasztorne Duże Lake in spring 2025 (©R. Augustyniak-Tunowska)

Since 2023 the promenade is constructed on Klasztorne Duże Lake shore (Fig. b.21). One of the element of recreational area development is the construction of beach infrastructure. Two piers were made for recreants and the official opening of city beach is planned before summer 2026 (Fig. b.22).

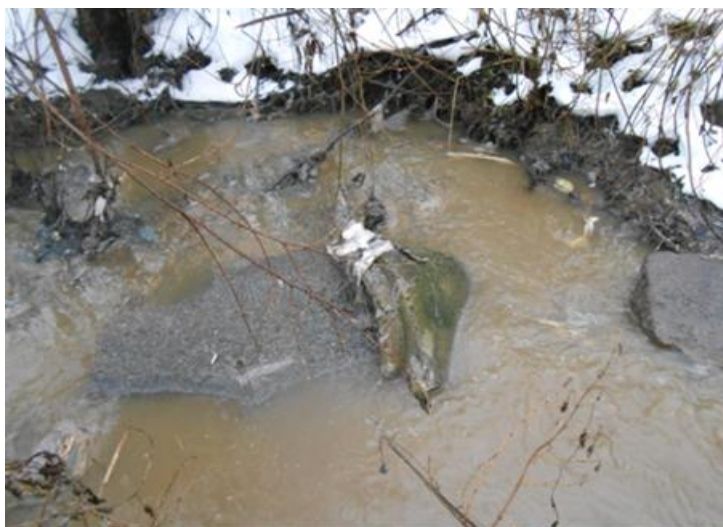
Figure b.24. Sewer No 17 - example of inflow to Karczemne Lake in 2012 (before restoration) (photo: J. Grochowska)

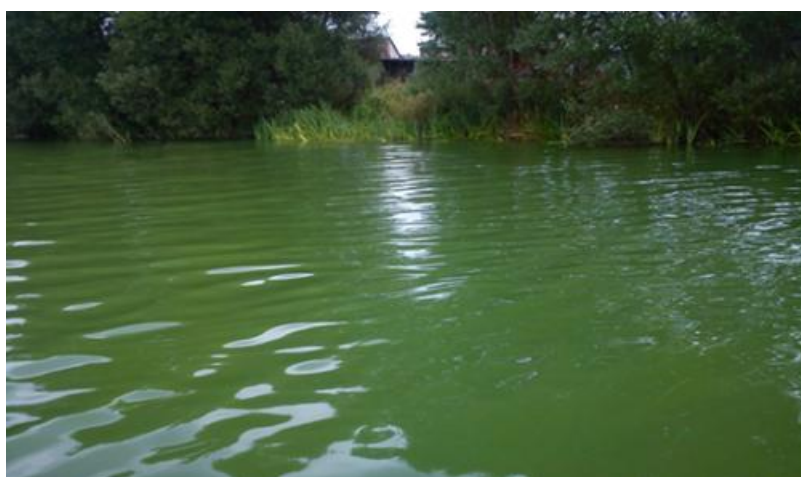
Figure b.25. Karczemne Lake before restoration - intensive cyanobacterial bloom (Photo: R. Augustyniak-Tunowska)

After sewerage modernization in the city (2015), the raw sewage was cut from the lake, but due to high P internal loading and P abundance in the bottom sediment, the only way to improve water quality in Karczemne Lake was to remove polluted sediment. High phosphorus level in the sediment opened the possibility of recycling the removed sediment for P reuse. Preliminary assessment of sediment volume dedicated to removal was 240,000 m³ (Grochowska et al. 2019, Thiemer et al. 2025)

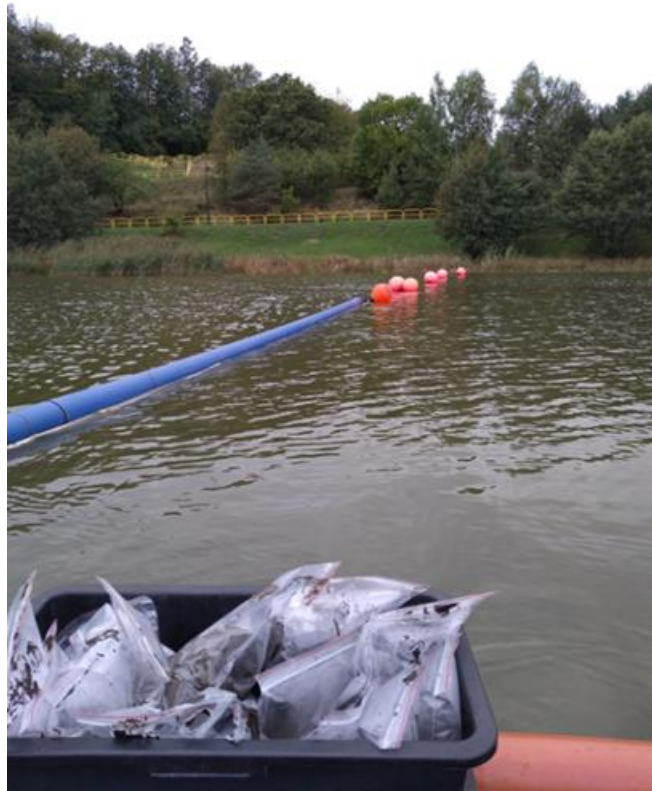
Figure b.27. Pipeline for sediment hydrotransport to Kartuzy WWTP (photo: J. Grochowska)

In cooperation with Kartuzy WWTP, the whole technological line was constructed for sediment treatment in the first half of 2020. Watered sediment was removed from the lake by refuler, and the sediment was directly hydrotransported via 4.5 km long pipeline into Kartuzy WWTP and stored in the large sedimentation tanks for preliminary dehydration. The removed pore water was directed to main sewage biological and chemical treatment line in WWTP. Preliminary dehydrated sediment was dehydrated again using grit chamber and centrifuges. The final product of dehydration was mixed with excessive active sludge from the main Kartuzy WWTP sewage technological line and stabilized. The physicochemical and microbiological parameters were checked according to standards, and the final soil-like product was dedicated for agricultural use beyond Kartuzy Lakes catchment.

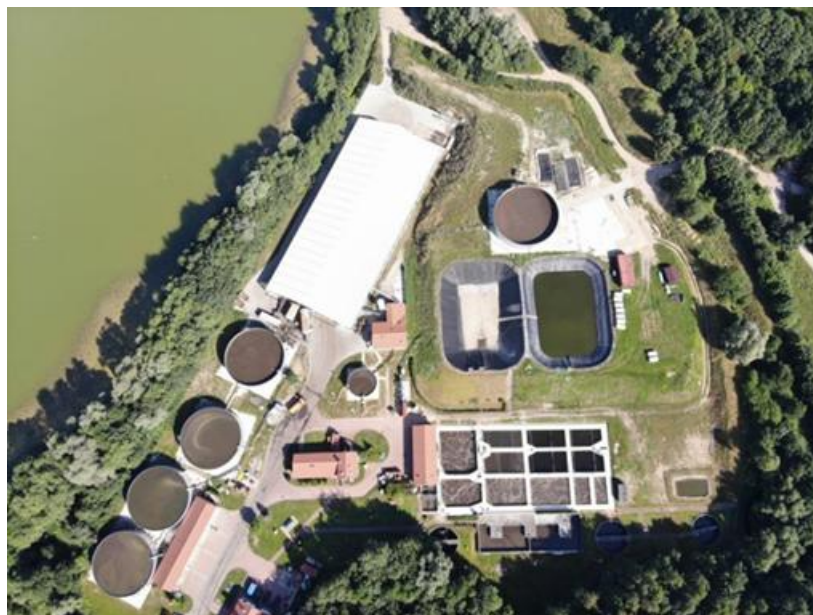
Figure b.28. Kartuzy WWTP aerial view during lake sediment treatment (Source: Kartuzy WWTP)

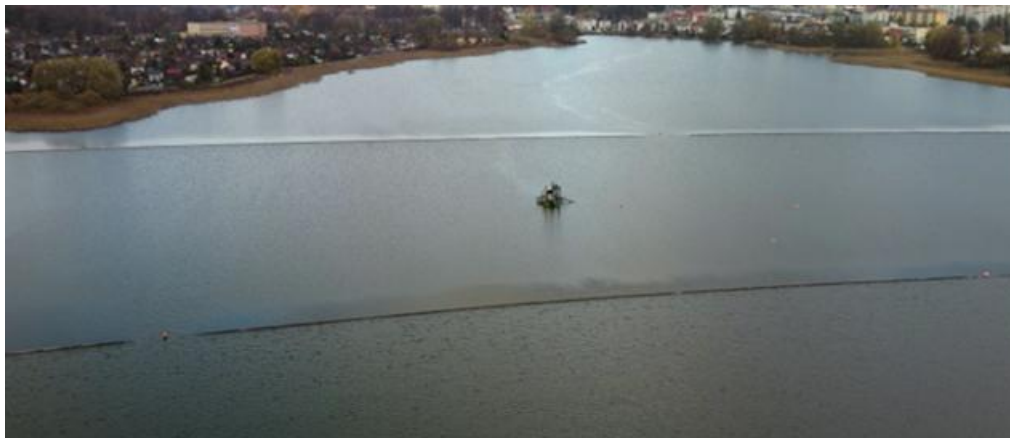
Figure b.29. Sediment removal from the part of Karczemne Lake – geomembrane curtains were used for separation of regulation area from the rest of lake (source: Kartuzy WWTP)

The process of sediment removal ended in 2023. The restoration of Kartuzy Lakes complex was financed by Kartuzy Municipality and EU (Infrastructure and Environment Operational Program). The total volume of processed mixture of water and sediment amounted to 1 mln m³.

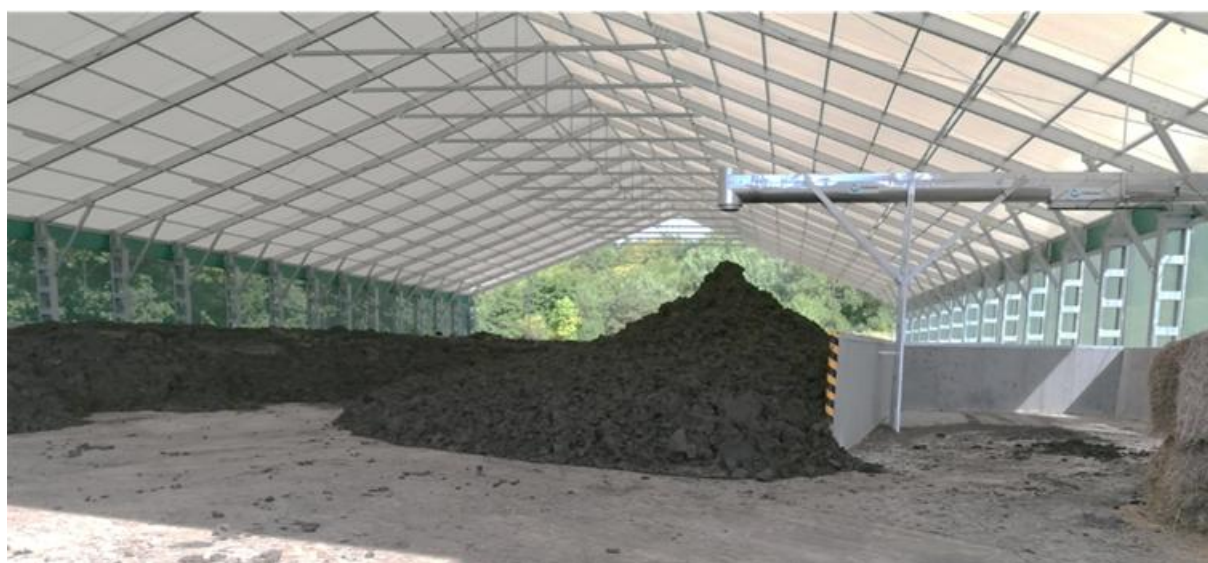
Figure b.30. Final product of sediment treatment in the storage shed (source: Kartuzy WWTP)

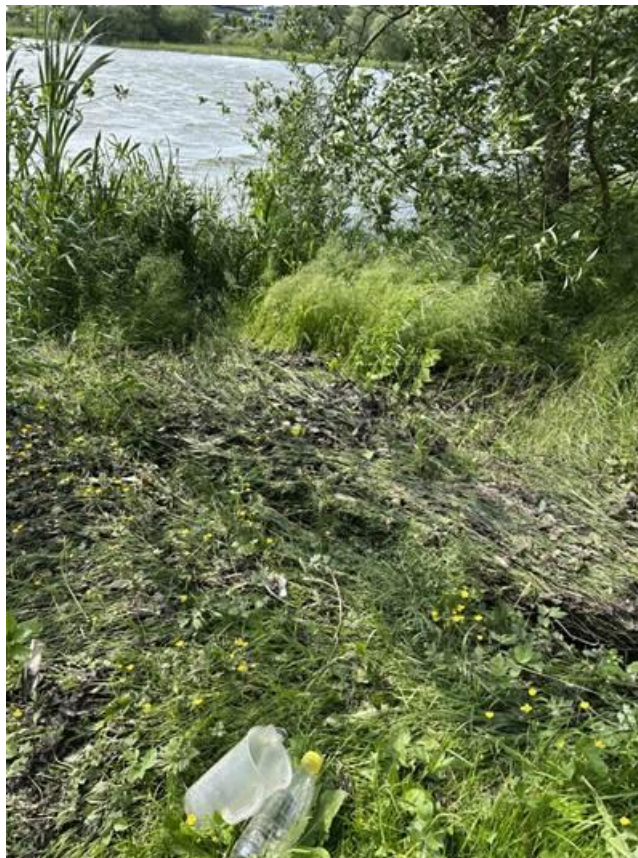
Figure b.32. The remains of big storm event on the shore of Karczemne Lake (the laid grass area shows the size of flow during heavy rain event, the collector is not active in standard conditions)(© R. Augustyniak-Tunowska).

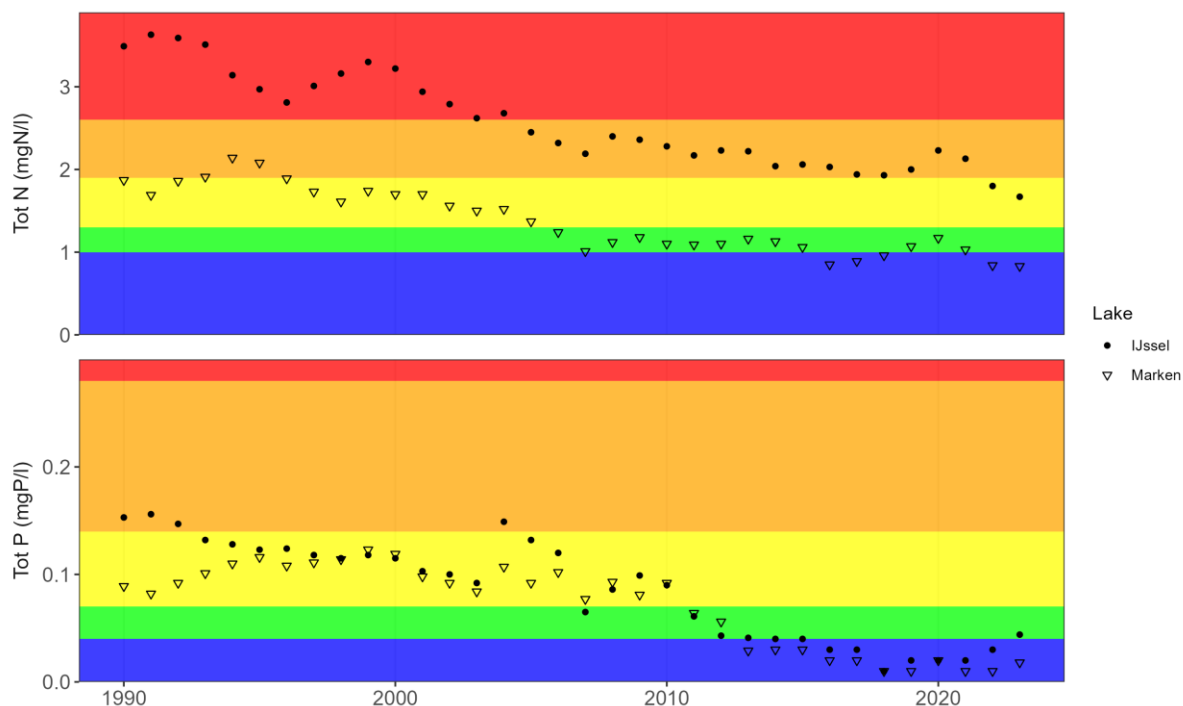
Figure C.7. 3-year summer averaged total nitrogen and total phosphorus concentrations and their respective statuses in Lake Marken and Lake IJssel between 1990 and 2024 according to (current) WFD thresholds. Data source: KRW-NUTrend (<https://krw-nutrend.netlify.app/>).

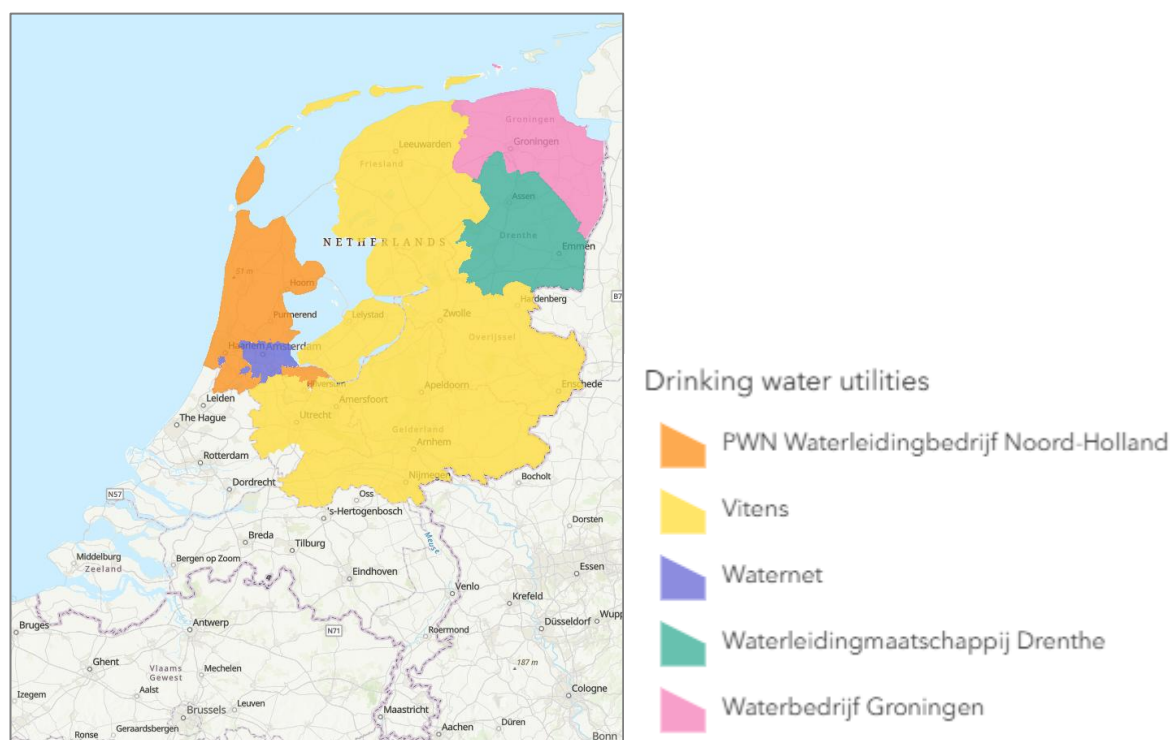
Figure C.26 Drinking water utilities in the Dutch part of the direct catchment of the Lake IJssel complex. This map was made with ESRI online resources.

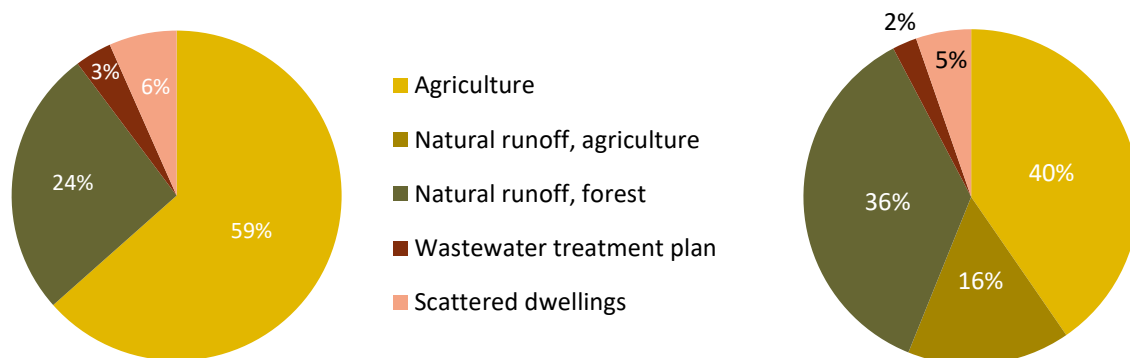
Figure f.4. The origins of the total phosphorus inputs to Storefjorden, as estimated by an independent analysis in 2001 (left pie, Lyche-Solheim et al. 2001) laying the basis for the implementation of mitigation measures in the Morsa catchment. The calculations were later updated with data from 2006 (right pie, Øygarden et al. 2010).
