## **Demonstrating Successful Restoration**

**Lake Vansjø Demonstration Site**

**Deliverable D4.1 DS-Annex f**

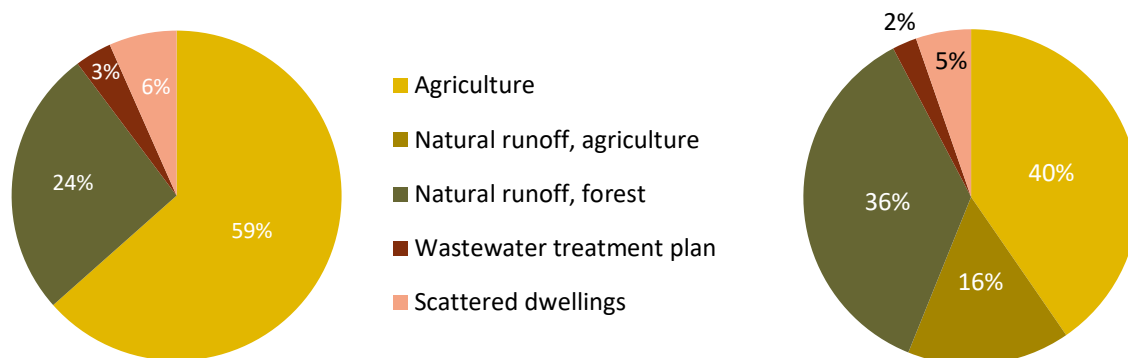
**Figure 4.** The origins of the total phosphorus inputs to Storefjorden, as estimated by an independent analysis in 2001 (left pie, Lyche-Solheim et al. 2001) laying the basis for the implementation of mitigation measures in the Morsa catchment. The calculations were later updated with data from 2006 (right pie, Øygarden et al. 2010).
